**Flood Control Project Maintenance  
Levee Inspections**

**Fall 2016 Levee Maintenance Deficiency Summary Report**

**Sacramento River Basin**

**Sutter Maintenance Yard Maintenance Area 0013**

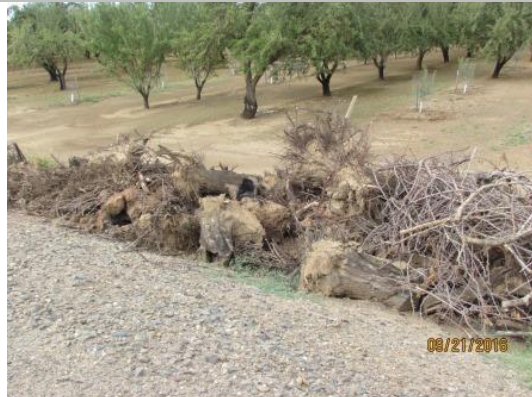
Photo 1 of 1 : FA\_2016\_MA0013\_300\_44\_20161010\_00079.jpg

LM Start	0.87	Rating **	U	Issue No.	44
LM End	0.87	Issue Type +	En	Location *	LS
Category	Earthen Levee			GPS Latitude/Longitude	
				Start	End
Item	Encroachments			39.585857 °	39.585857 °
				-121.700540 °	-121.700540 °
DWR ID	DWR_MA0013_01_s_2015_44				
Comment Code					
PR : Prunings					
Inspector Comment					
Remove the prunings from the landside slope.

View of the prunings and tree stumps along the landside slope.

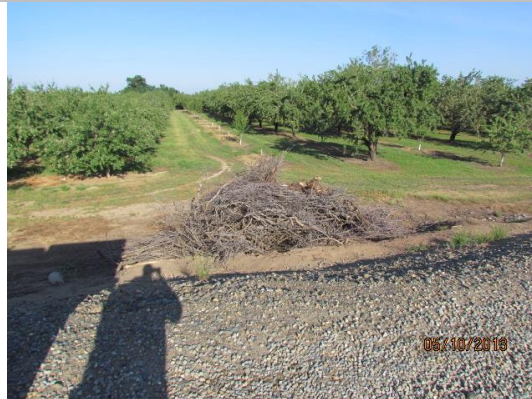
Photo 1 of 1 : FA\_2016\_MA0013\_300\_20\_20160823\_00009.jpg

LM Start	0.94	Rating **	M	Issue No.	20
LM End	0.94	Issue Type +	En	Location *	LS
Category	Earthen Levee			GPS Latitude/Longitude	
				Start	End
Item	Encroachments			39.584885 °	39.584885 °
				-121.700487 °	-121.700487 °
DWR ID	DWR_MA0013_01_s_2013_20				
Comment Code					
PR : Prunings					
Inspector Comment					
Remove prunings from the landside toe.

View of the prunings along the landside toe.

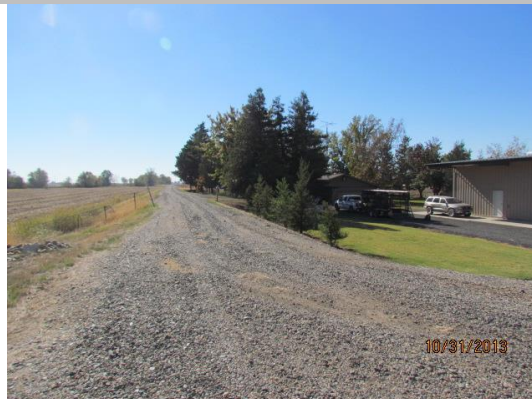
Photo 1 of 1 : FA\_2016\_MA0013\_300\_18\_20160823\_00008.jpg

LM Start	4.06	Rating **	M	Issue No.	18
LM End	4.13	Issue Type +	En	Location *	LS
Category	Earthen Levee			GPS Latitude/Longitude	
				Start	End
Item	Vegetation			39.541660 °	39.540651 °
				-121.707408 °	-121.707404 °
DWR ID	DWR_MA0013_01_s_2013_18				
Comment Code					
V6 : Landscaping					
Inspector Comment

View of the redwood trees along the landside slope.

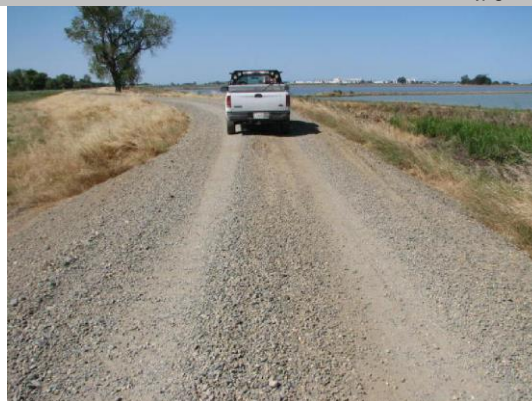
Photo 1 of 2 : UCIP\_FA\_2016\_47642\_66793.jpg

Comment Code					
Inspector Comment					
FS_ID:47642 DS_ID:16359 EP_NO: N/A Repair Type: Non-Urgent Crossing Status: Found UCIP Comments: 4/28/2016 WS gate and headwall are buried. Only the top of the headwall was visible. LS appeared ok.7/13/2015 Both the LS screw gate and WS flapgate are completely buried.5/21/2014 Same as last inspection.12/2/2013 Same as last inspection.7/15/2013 Slopes have been cleared of vegetation and are in good condition. WS headwall and flapgate are fully covered in debris and not visible. Need to clear.4/18/2012 High sedimentation build up at WS and LS headwall. Limited inspection due to dense vegetation on WS and LS slope. Need photo of cleared WS and LS slopes. This crossing was listed in the USACE Periodic Inspection report as Corp's inspect ID# USACE_CESPK_M13D_2011_p_0210 for WS gate submerged. FIELD_STRUCT_DESC: 24-inch corrugated metal drainage pipe through the levee, 9.2 feet below the crown. Flap gate on the waterside (WS) end. Concrete "U" headwalls on both ends. [Additional Reference(s): DWR Levee Log, 1993. USACE Sacramento O&M Manual 519, June 1962 (HLM 5.73)] FS Date: 5/4/2016 8:56:00 AM

Overview of levee crown at crossing looking downstream.

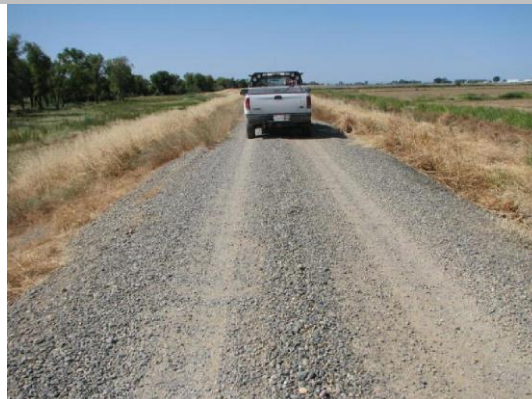
Photo 1 of 2 : UCIP\_FA\_2016\_47644\_66808.jpg

FS\_ID:47644  
DS\_ID:16361  
EP\_NO: N/A  
Repair Type: Non-Urgent  
Crossing Status: Found  
UCIP Comments: 4/28/2016 LS screwgate is still completely buried.

Overview of levee crown at crossing looking downstream.

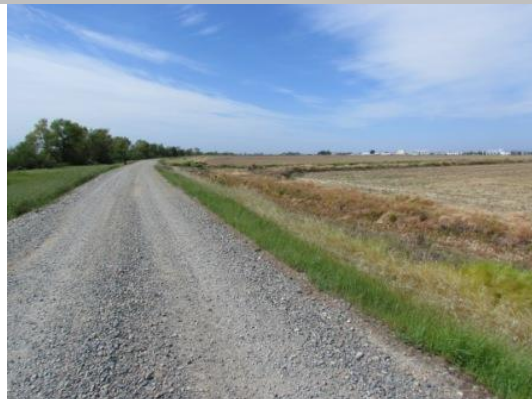
Photo 1 of 1 : FA\_2016\_MA0013\_300\_3\_20160823\_00002.jpg

LM Start	6.41	Rating **	M	Issue No.	3
LM End	6.99	Issue Type +	En	Location *	LS
Category	Earthen Levee			GPS Latitude/Longitude	
				Start	End
Item	Encroachments			39.508928 °	39.501438 °
				-121.714842 °	-121.719715 °
DWR ID	DWR_MA0013_01_s_2012_3				
Comment Code					
DT : Ditch					
Inspector Comment

View of the agricultural ditch along the toe.

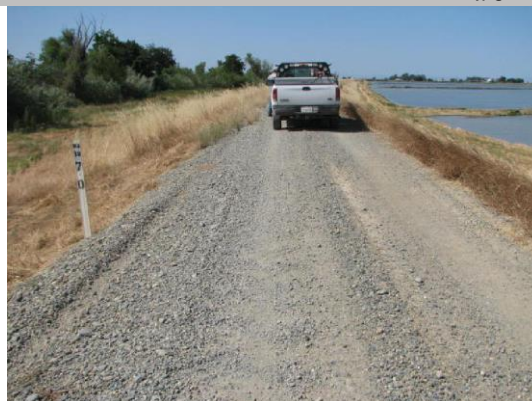
Photo 1 of 2 : UCIP\_FA\_2016\_47689\_66833.jpg

Overview of levee crown at crossing looking D/S.

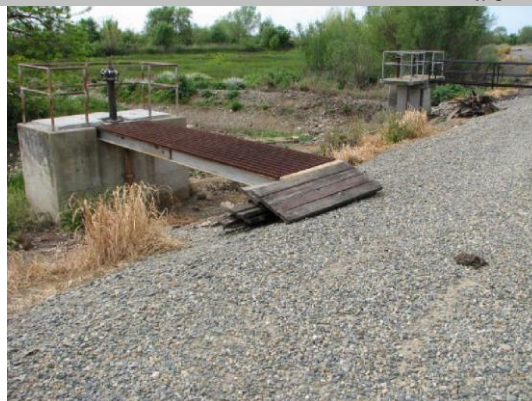
Photo 1 of 2 : UCIP\_FA\_2016\_49924\_66881.jpg

Catwalk and screw gate located on WS.

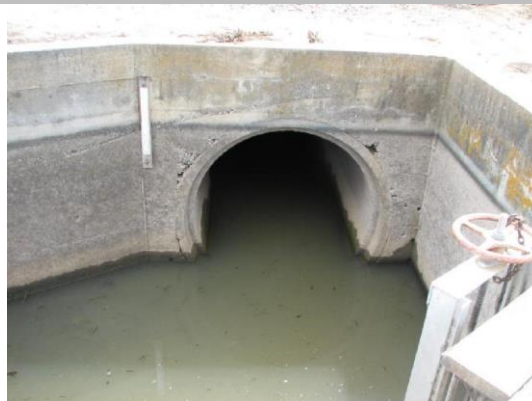
Photo 2 of 2 : UCIP\_FA\_2016\_47664\_66907.jpg

Headwall at LS distribution box

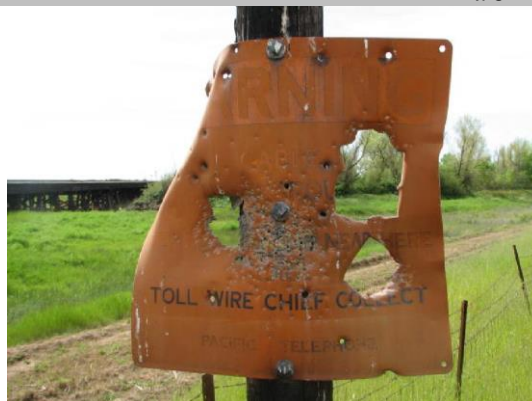
Photo 1 of 1 : UCIP\_FA\_2016\_47447\_66909.jpg

Comment Code					
Inspector Comment					
FS_ID:47447 DS_ID:16328 EP_NO: 1234A Repair Type: Non-Urgent Crossing Status: Indicator Found UCIP Comments: 4/28/2016 Marker missing on WS.7/13/2015 Crossing appears in good condition. No noticeable issues to report.Need to contact owner to replace marker.7/15/2013 Same as last inspection.12/3/2013 Same as last inspection.5/21/2014 Same as last inspection. FIELD_STRUCT_DESC: Underground telephone cable through the levee at an unknown depth below the crown. (Permit No. 1234, 1234A, 1947 - Pacific Telephone and Telegraph Company [PT&T]) [Additional Reference(s): DWR Levee Log, 1993] FS Date: 5/4/2016 10:13:29 AM

Underground telephone cable marker located on WS.

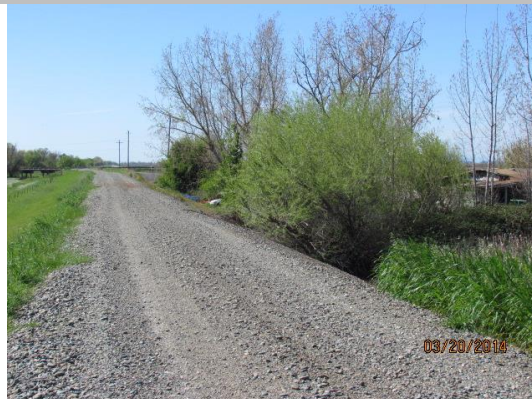
Photo 1 of 1 : FA\_2016\_MA0013\_300\_5\_20160823\_00003.jpg

LM Start	9.70	Rating **	M	Issue No.	5
LM End	9.72	Issue Type +	Ma	Location *	LS
Category	Earthen Levee			GPS Latitude/Longitude	
				Start	End
Item	Trim / Thin Trees			39.467170 °	39.466860 °
				-121.743887 °	-121.744108 °
DWR ID	DWR_MA0013_01_s_2012_5				
Comment Code					
T1 : Trim trees to at least five feet above ground level.					
Inspector Comment

View of the overgrown trees along the landside slope and toe.

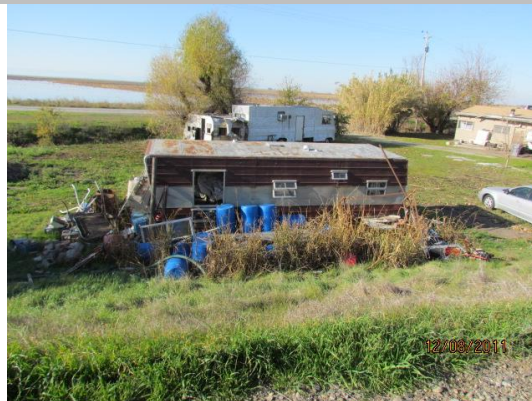
Photo 1 of 1 : FA\_2016\_MA0013\_300\_10\_20160823\_00005.jpg

LM Start	9.73	Rating **	M	Issue No.	10
LM End	9.75	Issue Type +	En	Location *	LS
Category	Earthen Levee			GPS Latitude/Longitude	
				Start	End
Item	Encroachments			39.466732 °	39.466478 °
				-121.744180 °	-121.744338 °
DWR ID	DWR_MA0013_01_f _ 2013_10				
Comment Code					
MA : Material					
Inspector Comment					
Move the trailer and materials outside the 10 foot easement.

View of a trailer and material along the landside toe.

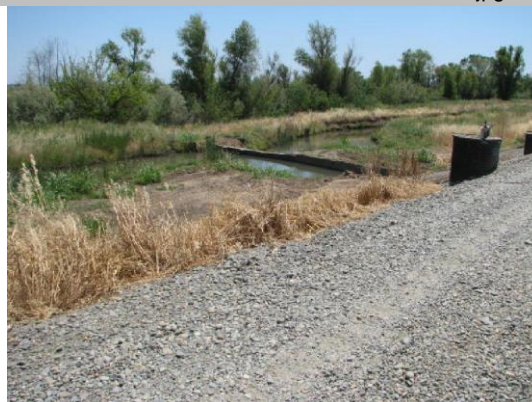
Photo 2 of 2 : UCIP\_FA\_2016\_47672\_66936.jpg

View of WS slope and channel.

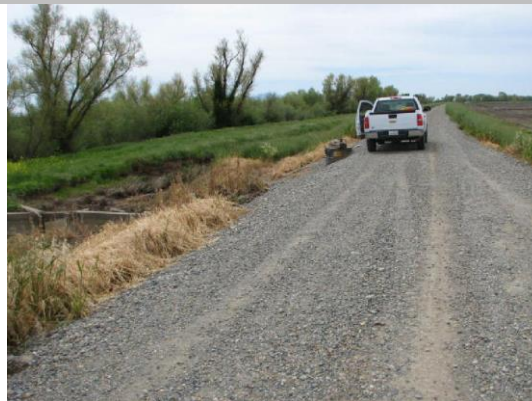
Photo 1 of 2 : UCIP\_FA\_2016\_48049\_66952.jpg

Comment Code					
Inspector Comment					
FS_ID:48049 DS_ID:16336 EP_NO: N/A Repair Type: Non-Urgent Crossing Status: Found UCIP Comments: 4/28/2016 Slide gate was removed from inside the WS standpipe.7/13/2015 New screw gate installed on the WS pipe end in the irrigation ditch.5/21/2014 Same as last inspection.12/3/2013 Same as last inspection.7/15/2013 Same as last inspection.4/18/2012 Irrigation turnout. Not in use during April 2012 Inspection. During the follow up May 2012 Inspection structure was being used as irrigation turnout, reason for barcode tags. FIELD_STRUCT_DESC: 30-inch corrugated metal drainage pipe through the levee, 10.7 feet below the crown. Slide gate in corrugated metal pipe (CMP) riser on the waterside (WS) slope. Concrete "U" headwalls on both ends. This crossing is used as an irrigation turnout bar code plate located on the WS slide gate (identified as 141 and 142). [Additional Reference(s): DWR Levee Log, 1993. USACE Sacramento O&M Manual 519, June 1962 (HLM 12.94)] FS Date: 5/4/2016 12:22:00 PM

Overview picture looking south on right bank of Cherokee Canal.

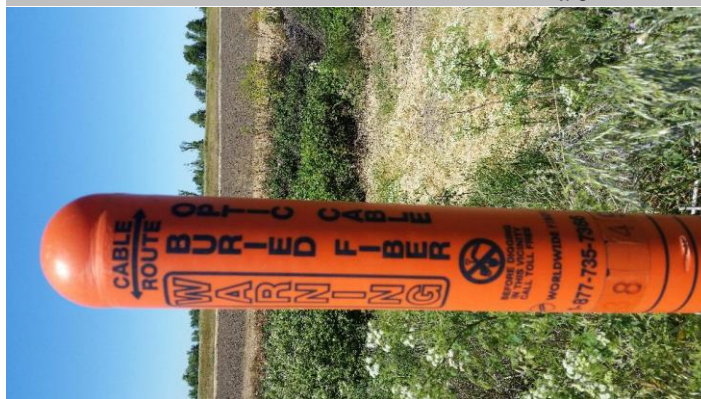
Photo 1 of 2 : UCIP\_FA\_2016\_48060\_75014.jpg

Marker located along side of road about 200 yds east of levees

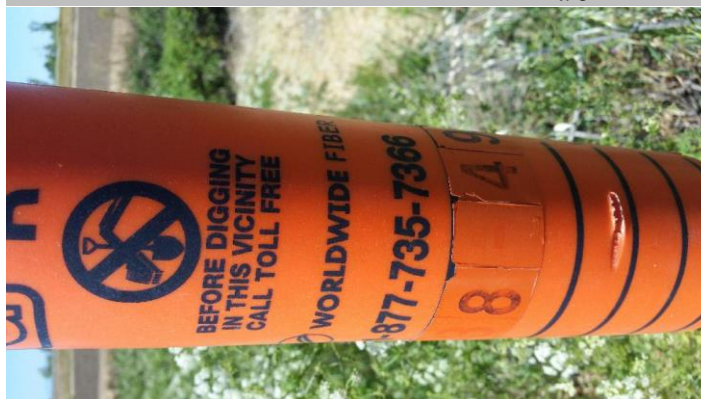
Photo 2 of 2 : UCIP\_FA\_2016\_48060\_75015.jpg

Crossing owner contact info

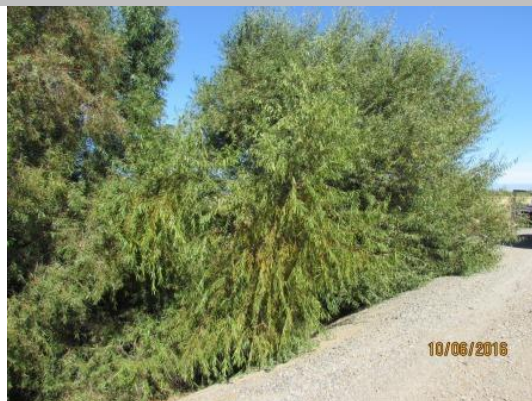
Photo 1 of 1 : FA\_2016\_MA0013\_300\_61\_20161010\_00086.jpg

LM Start	13.76	Rating **	U	Issue No.	61
LM End	13.76	Issue Type +	Ma	Location *	LS
Category	Earthen Levee			GPS Latitude/Longitude	
				Start	End
Item	Trim / Thin Trees			39.416854 °	39.416854 °
				-121.781855 °	-121.781855 °
DWR ID	DWR_MA0013_01_f_2016_61				
Comment Code					
T1 : Trim trees to at least five feet above ground level.					
Inspector Comment

View of the overgrown trees and vegetation along the landside slope and toe.

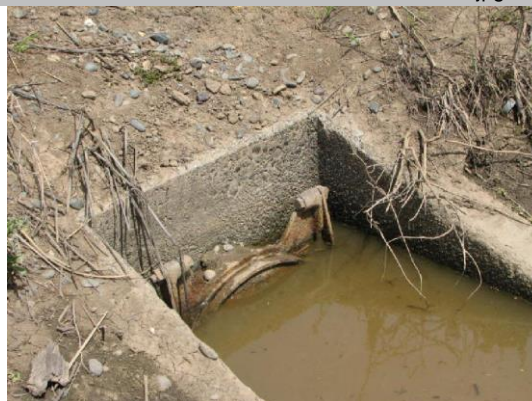
Photo 1 of 2 : UCIP\_FA\_2016\_47677\_66970.jpg

Comment Code					
Inspector Comment					
FS_ID:47677 DS_ID:16338 EP_NO: N/A Repair Type: Non-Urgent Crossing Status: Found UCIP Comments: 5/3/2016 Crossing appears to be abandoned. WS flap gate was completely silted over and LS slide gate is very overgrown by a tree.7/13/2015 WS flap gate is blocked from opening by sediment and vegetation. Needs to be cleared away. LS opening is being over grown by a tree and needs to be cutback.5/22/2014 Same as last inspection.12/3/2013 Same as last inspection.7/15/2013 Same as last inspection.4/18/2012 Tree has fallen at LS inlet and damaged slide gate. The tree needs to be removed and screw gate repaired. Limited inspection on LS due to fallen tree. FIELD_STRUCT_DESC: 24-inch corrugated metal drainage pipe through the levee, 12.7 feet below the crown. Flap gate on the waterside (WS). Concrete "U" headwall on both ends. [Additional Reference(s): DWR Levee Log, 1993. USACE Sacramento O&M Manual 519, June 1962 (HLM 13.96)] FS Date: 5/4/2016 12:36:00 PM

WS headwall and flap gate.

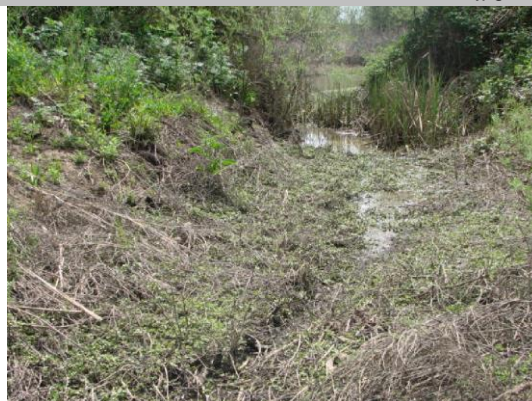
Photo 2 of 2 : UCIP\_FA\_2016\_47677\_66971.jpg

Item	DWR UCIP Field Study			39.416833 °	39.416833 °	
				-121.781930 °	-121.781930 °	
DWR ID						
Comment Code						
Inspector Comment						
FS_ID:47677						
DS_ID:16338						
EP_NO: N/A						
Repair Type: Non-Urgent						
Crossing Status: Found						
UCIP Comments: 5/3/2016 Crossing appears to be abandoned. WS flap gate was completely silted over and LS slide gate is very overgrown by a tree.7/13/2015 WS flap gate is blocked from opening by sediment and vegetation. Needs to be cleared away. LS opening is being over grown by a tree and needs to be cutback.5/22/2014 Same as last inspection.12/3/2013 Same as last inspection.7/15/2013 Same as last inspection.4/18/2012 Tree has fallen at LS inlet and damaged slide gate. The tree needs to be removed and screw gate repaired. Limited inspection on LS due to fallen tree.						
FIELD_STRUCT_DESC: 24-inch corrugated metal drainage pipe through the levee, 12.7 feet below the crown. Flap gate on the waterside (WS). Concrete "U" headwall on both ends. [Additional Reference(s): DWR Levee Log, 1993. USACE Sacramento O&M Manual 519, June 1962 (HLM 13.96)]

View of channel at crossing.

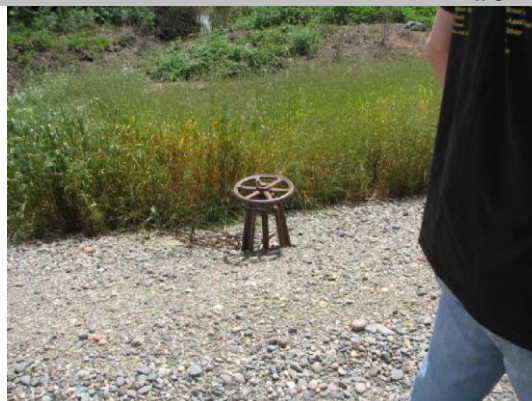
Photo 1 of 2 : UCIP\_FA\_2016\_48050\_66972.jpg

FS\_ID:48050  
DS\_ID:16339  
EP\_NO: N/A  
Repair Type: Non-Urgent  
Crossing Status: Found  
UCIP Comments: 5/03/2016 ABANDONED CROSSING 7/13/2015  
Abandoned crossing. Slide gate is buried on the WS. 5/22/2014 Same as last inspection. 12/3/2013 Same as last inspection. 7/15/2013 Same as last inspection. 4/18/2012 Non-functional crossing-buried slide gate on WS. Limited inspection on WS and LS slope/toe due to dense vegetation. Need photo of cleared WS & LS slopes or toe. This crossing is listed in the USACE periodic inspection report as Corp's Inspection ID# USACE\_CESPK\_M13D\_2011\_p\_0352 for abandoned gate on WS slope.  
FIELD\_STRUCT\_DESC: \*ABANDONED\* 12-inch steel drainage pipe through the levee, 3 feet below the crown. Gate valve on the waterside (WS) slope. 0.25-inch steel plate welded on both ends. [Additional Reference(s): DWR Levee Log, 1993. USACE Sacramento O&M Manual 519, June 1962 (HLM 13.97)]

Buried slide gate on the WS slope.

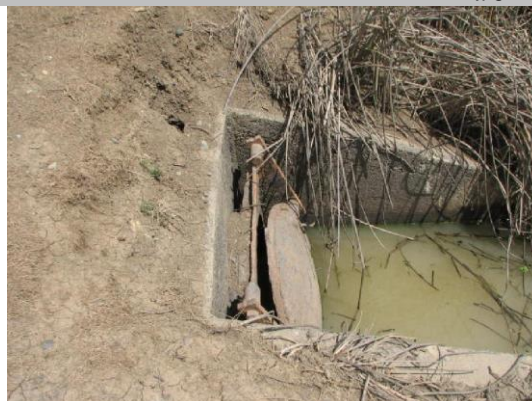
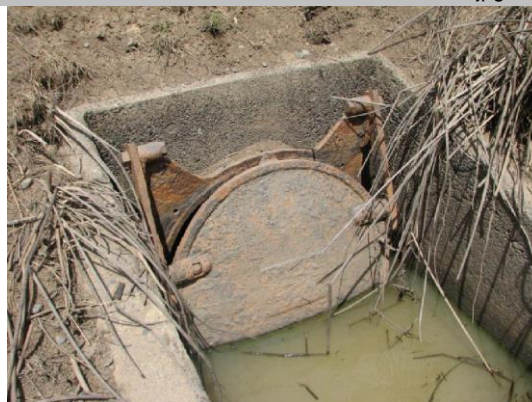
FS\_ID:49925  
DS\_ID:16368  
EP\_NO: N/A  
Repair Type: Urgent  
Crossing Status: Found  
UCIP Comments: 5/03/2016 Top of the pipe on the WS has holes in it between the flapgate flange and headwall. Crossing is showing signs of rust and deterioration but it was mostly underwater so could not inspect the inside of the pipe. (DWR Sutter Yard - afreitag)7/13/2015 Both sides of crossing were underwater at the time of inspection. (DWR Sutter Yard - afreitag)5/22/2014 Same as last inspection. (DWR Sutter Yard - afreitag)12/3/2013 Same as last inspection. (DWR Sutter Yard - afreitag)7/15/2013 Slopes have been cleared of vegetation and are in good condition. WS flapgate is still lodged open. (DWR Sutter Yard - afreitag)4/18/2012 Limited inspection on LS slope due to dense vegetation. Need photos of cleared WS & LS slopes. The flap gate is lodged open. (DWR UCIP - omagana)  
FIELD\_STRUCT\_DESC: 36-inch corrugated metal drainage pipe through the levee, 12.9 feet below the crown. Concrete "U" headwalls on both waterside (WS) and landside (LS) ends. Flap gate on the WS end. [Additional Reference(s): DWR Levee Log, 1993. USACE Sacramento O&M Manual 519, June 1962 (HLM 14.79)]

Headwall and flapgate located on water side of levee

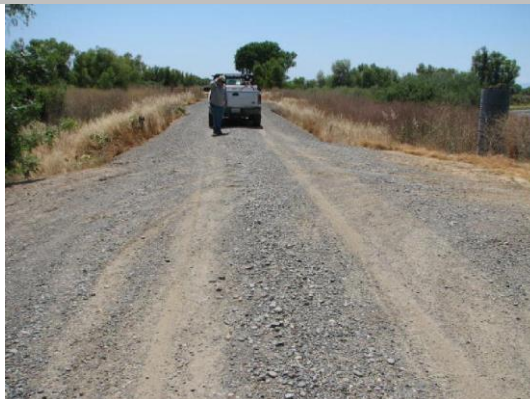
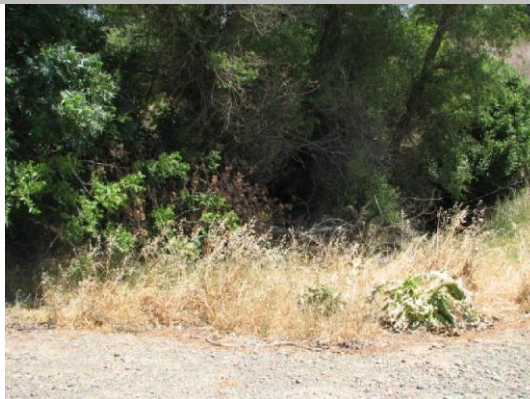
FS\_ID:48494  
DS\_ID:16364  
EP\_NO: 7521  
Repair Type: Non-Urgent  
Crossing Status: Found  
UCIP Comments: 5/3/2016 Tree near the WS pipe end has been cut down. Stump is still in place. Water was too high to be able to see if the pipe inside was damaged. Minor erosion starting behind the WS headwall.7/13/2015 WS pipe end is heavily vegetated with trees and is making it almost impossible to inspect. Needs to be cleared out. LS appears in good condition.5/22/2014 Same as last inspection.12/3/2013 Same as last inspection.7/15/2013 Slopes have been cleared of vegetation and are in good condition.4/18/2012 Limited inspection on WS and LS slopes/toe due to dense vegetation. Erosion behind headwall on WS toe. Need photos of cleared WS & LS slopes.  
FIELD\_STRUCT\_DESC: 30-inch corrugated metal drainage pipe through the levee, 13.6 feet below the crown. Flap gate on the waterside (WS) end. Concrete "U" headwalls on both ends. A 48-inch corrugated metal standpipe located approximately 12 feet from landside (LS) levee toe. (Permit No. 7521, 1972 - Askew Ranch) [Additional Reference(s): DWR Levee Log, 1993. USACE Sacramento O&M Manual 519, June 1962 (HLM 15.95)]

Overview of levee crown at crossing looking downstream.

View of WS.

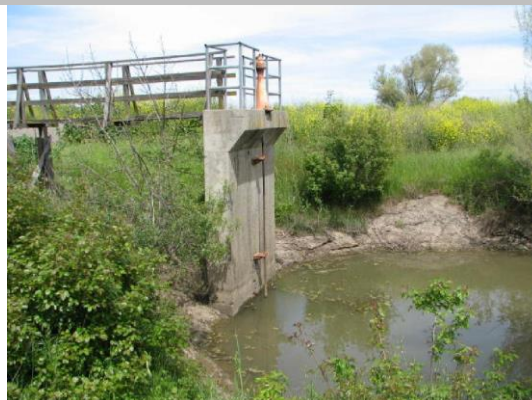
FS\_ID:48059  
DS\_ID:16373  
EP\_NO: 11805B  
Repair Type: Non-Urgent  
Crossing Status: Found  
UCIP Comments: 5/03/2016 Crossing was underwater on both sides of levee during this inspection. Looks as if the wooden walkway was the same and no repairs have been made.7/13/2015 LS inlet still underwater. WS screwgate appears in good condition. Wooden walkway to the screwgate needs repairs.5/22/2014 Same as last inspection.12/3/2013 Same as last inspection.7/15/2013 Same as last inspection.4/18/2012 LS inlet is not visible-underwater. Limited inspection on WS and LS slope/toe due to dense vegetation. Need photos of cleared WS & LS slopes.  
FIELD\_STRUCT\_DESC: 48-inch reinforced concrete irrigation pipe with six concrete collars through the levee, 14.4 feet below the crown to center of conduit. Slide gate, head-wall and wood walkway on two concrete piers on the waterside (WS) of levee. Revetment on the WS slope. Irrigation ditch on the landside (LS). (Permit No. 11805, 11805B, 1979 - Elna Schohr, Inc.) [Additional Reference(s): DWR Levee Log, 1993]

WS view of appurtenances (catwalk, slide gate, and headwall)

WS view of catwalk, slide/screw gate, and headwall

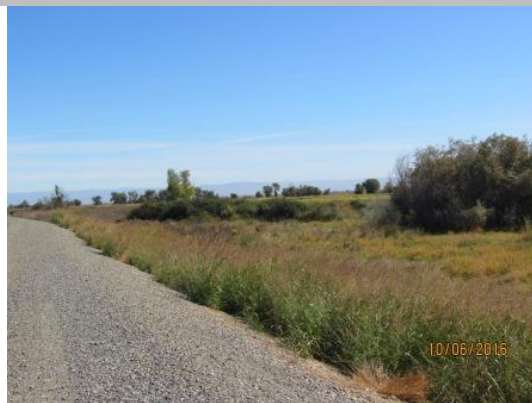
Photo 1 of 1 : FA\_2016\_MA0013\_300\_53\_20161010\_00081.jpg

LM Start	18.53	Rating **	M	Issue No.	53
LM End	18.59	Issue Type +	Ma	Location *	WS
Category	Earthen Levee			GPS Latitude/Longitude	
				Start	End
Item	Vegetation			39.373165 °	39.372718 °
				-121.850902 °	-121.851840 °
DWR ID	DWR_MA0013_01_f_2016_53				
Comment Code					
V1 : Control annual grass and weeds on the levee slopes and easements.					
Inspector Comment

View of the dense vegetation along the landside slope and toe.

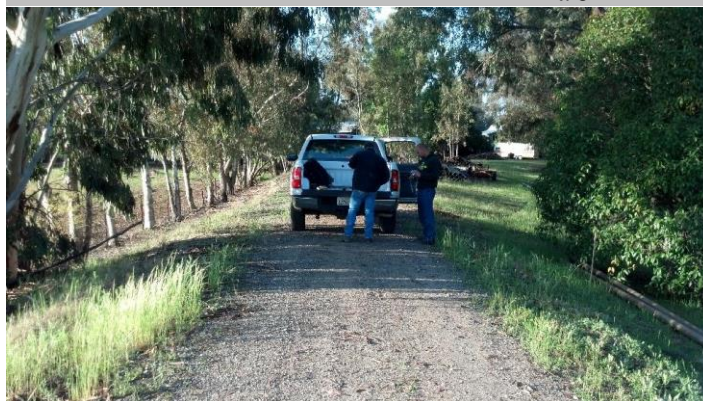
Photo 1 of 2 : UCIP\_FA\_2016\_50045\_45640.jpg

FS\_ID:50045  
DS\_ID:16397  
EP\_NO: N/A  
Repair Type: Non-Urgent  
Crossing Status: Found  
UCIP Comments: 9/27/2016 Crossing has been downgraded from Urgent to Non-Urgent--sleeved pipe does not prevent flap gate from closing on WS. Still need to coordinate with owner to remove sleeved pipe through existing crossing per Title 23. (DWR UCIP - omagana)4/27/216 Crossing appears to be in good condition. 4 inch pipe is still present in LS opening but does not go all the way through to the WS. (DWR Sutter Yard - afreitag)7/01/2015 Crossing appears in good condition. No noticeable issues to report. (DWR Sutter Yard - afreitag)5/29/2014 Same as last inspection. (DWR Sutter Yard - afreitag)12/9/2013 4in. Pipe was removed and flapgate is closed and ready for high water. (DWR Sutter Yard - afreitag)7/10/2013 Same as last inspection. Urgency rating carry over from last entry. (DWR Sutter Yard - afreitag)4/19/2012 4-6 inch pipe is not part of original crossing--remove pipe. WS-pipe stockpile on WS slope. LS-Overgrown branches limit inspection. This crossing was listed in the USACE Periodic Inspection report listed as Corp's Inspect ID# USACE\_CESPK\_M13G\_2011\_p\_0009 for WS flap gate not functioning properly as irrigation pipe passes inside crossing. (DWR UCIP - omagana)

Overview looking south on left levee

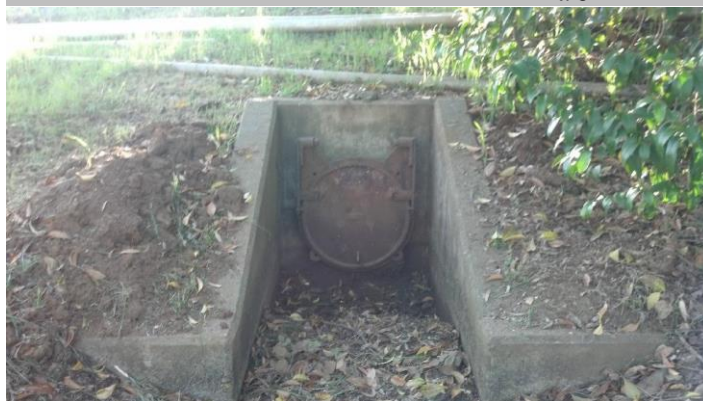
Photo 2 of 2 : UCIP\_FA\_2016\_50045\_45642.jpg

FS\_ID:50045  
DS\_ID:16397  
EP\_NO: N/A  
Repair Type: Non-Urgent  
Crossing Status: Found  
UCIP Comments: 9/27/2016 Crossing has been downgraded from Urgent to Non-Urgent--sleeved pipe does not prevent flap gate from closing on WS. Still need to coordinate with owner to remove sleeved pipe through existing crossing per Title 23. (DWR UCIP - omagana)4/27/216 Crossing appears to be in good condition. 4 inch pipe is still present in LS opening but does not go all the way through to the WS. (DWR Sutter Yard - afreitag)7/01/2015 Crossing appears in good condition. No noticeable issues to report. (DWR Sutter Yard - afreitag)5/29/2014 Same as last inspection. (DWR Sutter Yard - afreitag)12/9/2013 4in. Pipe was removed and flapgate is closed and ready for high water. (DWR Sutter Yard - afreitag)7/10/2013 Same as last inspection. Urgency rating carry over from last entry. (DWR Sutter Yard - afreitag)4/19/2012 4-6 inch pipe is not part of original crossing--remove pipe. WS-pipe stockpile on WS slope. LS-Overgrown branches limit inspection. This crossing was listed in the USACE Periodic Inspection report listed as Corp's Inspect ID# USACE\_CESPK\_M13G\_2011\_p\_0009 for WS flap gate not functioning properly as irrigation pipe passes inside crossing. (DWR UCIP - omagana)

Headwall and flap gate on WS. Soil and pipes stockpiled next to headwall.

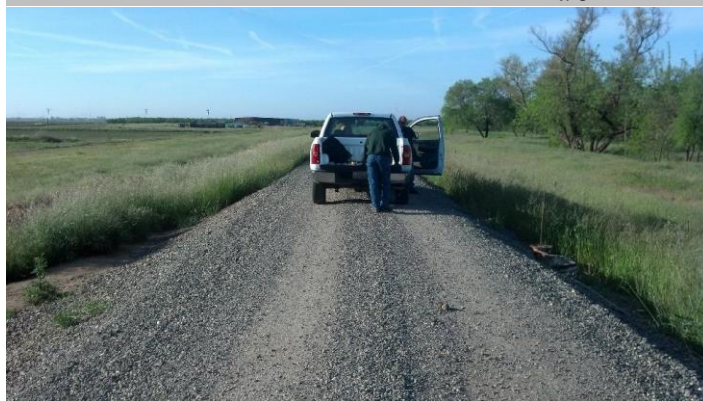
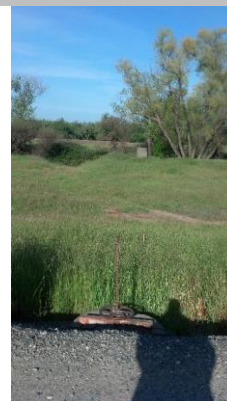
FS\_ID:48038  
DS\_ID:16398  
EP\_NO: N/A  
Repair Type: Non-Urgent  
Crossing Status: Found  
UCIP Comments: 4/27/2016 Pipe gets used by the landowner to irrigate his rice fields. It appeared to be in good condition.7/01/2015 LS pipe end is still about 50% full of sediment.5/29/2014 Same as last inspection.12/9/2013 Same as last inspection.7/10/2013 LS and WS slopes have been cleared of vegetation and are in good condition. LS pipe end is half full of sediment. Sediment inside of WS standpipe may hinder slide gate from fully closing. Standpipe cover is still broken.4/19/2012 Need to fix the top of slide gate cover. The wooden cap on standpipe is broken. Limited evaluation of crossing due to dense vegetation on LS slope. Need photos of cleared slopes during fall inspection.  
FIELD\_STRUCT\_DESC: 24-inch corrugated metal drainage pipe through the levee, 10.6 feet below the crown. Slide gate in corrugated metal pipe (CMP) riser on the waterside (WS) slope. Concrete "U" headwall on the landside (LS). 36-inch concrete standpipe in the channel with two wooden piles to deflect debris. [Additional Reference(s): DWR Levee Log, 1993. USACE Sacramento O&M Manual 519, June 1962 (HLM 0.57)]

Overview looking south

View of WS slope and toe.

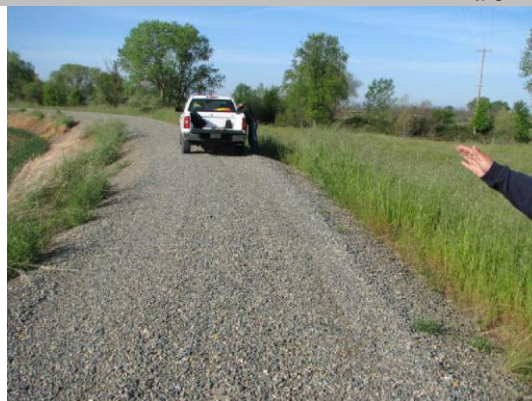
Photo 1 of 2 : UCIP\_FA\_2016\_48039\_67059.jpg

Comment Code					
Inspector Comment					
FS_ID:48039 DS_ID:16399 EP_NO: N/A Repair Type: Non-Urgent Crossing Status: Found UCIP Comments: 4/27/2016 LS screw gate is still bent. Rest of crossing appeared in good condition.7/01/2015 LS screw gate frame is still twisted and hindering the gate from opening.5/29/2014 Same as last inspection.12/9/2013 Same as last inspection.7/10/2013 WS slope is cleared of vegetation and is in good condition. LS screw gate frame is twisted and is preventing the gate from opening.4/19/2012 Limited inspection dense vegetation on WS. Need photos of clear WS slope & toe. Ditch present in channel? This crossing was listed in the USACE Periodic Inspection report as Corp's Inspect ID# USACE_CESPK_M13G_2011_p_0108 for WS flap gate filled with soil and LS gate not functioning because of overgrown vegetation. FIELD_STRUCT_DESC: 24-inch corrugated metal drainage pipe through the levee, 7.9 feet below the crown. Concrete "U" headwalls on both waterside (WS) and landside (LS) ends. Flap gate on the WS end. Slide gate at the LS toe in headwall. In 1962, permit number 3953 was issue for existing pump structure, intake box, ditch and power pole. In 1963, the pump and intake box were removed. (Permit No. 3953, 1960 - Dr. John O. Gibbs, DBA Empire Land Company) [Additional Reference(s): DWR Levee Log, 1993. USACE Sacramento O&M Manual 519, June 1962 (HLM 1.70)] FS Date: 5/3/2016 12:53:00 PM

Overview of crossing

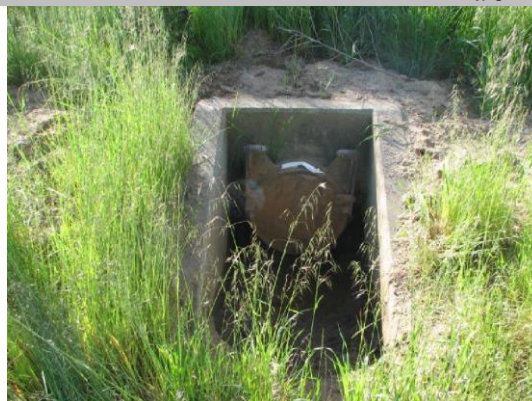
Photo 2 of 2 : UCIP\_FA\_2016\_48039\_67058.jpg

Item	DWR UCIP Field Study			39.551178 °	39.551178 °	
				-121.705660 °	-121.705660 °	
DWR ID						
Comment Code						
Inspector Comment						
FS_ID:48039 DS_ID:16399 EP_NO: N/A Repair Type: Non-Urgent Crossing Status: Found UCIP Comments: 4/27/2016 LS screw gate is still bent. Rest of crossing appeared in good condition.7/01/2015 LS screw gate frame is still twisted and hindering the gate from opening.5/29/2014 Same as last inspection.12/9/2013 Same as last inspection.7/10/2013 WS slope is cleared of vegetation and is in good condition. LS screw gate frame is twisted and is preventing the gate from opening.4/19/2012 Limited inspection dense vegetation on WS. Need photos of clear WS slope & toe. Ditch present in channel? This crossing was listed in the USACE Periodic Inspection report as Corp's Inspect ID# USACE_CESPK_M13G_2011_p_0108 for WS flap gate filled with soil and LS gate not functioning because of overgrown vegetation. FIELD_STRUCT_DESC: 24-inch corrugated metal drainage pipe through the levee, 7.9 feet below the crown. Concrete "U" headwalls on both waterside (WS) and landside (LS) ends. Flap gate on the WS end. Slide gate at the LS toe in headwall. In 1962, permit number 3953 was issue for existing pump structure, intake box, ditch and power pole. In 1963, the pump and intake box were removed. (Permit No. 3953, 1960 - Dr. John O. Gibbs, DBA Empire Land Company) [Additional Reference(s): DWR Levee Log, 1993. USACE Sacramento O&M Manual 519, June 1962 (HLM 1.70)] FS Date: 5/3/2016 12:53:00 PM

View of flap gate on WS.

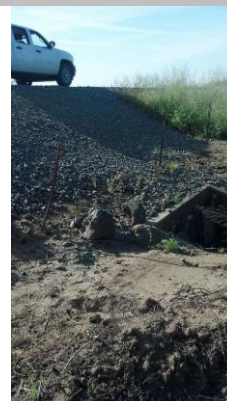
Comment Code						
Inspector Comment						
FS_ID:48040 DS_ID:16400 EP_NO: N/A Repair Type: Non-Urgent Crossing Status: Found UCIP Comments: 4/27/2016 WS flapgate still blocked from opening by sediment buildup.7/01/2015 New screwgate installed on the LS. WS flapgate is still blocked from opening by sediment.5/29/2014 Same as last inspection.12/9/2013 Same as last inspection.7/10/2013 Sediment is built up against WS flap gate not allowing it to open. Handle for LS slide gate is still missing.4/19/2012 Handle missing on slide gate. FIELD_STRUCT_DESC: 1 of 2: 36-inch corrugated metal drainage pipe through the levee, 9.7 feet below the crown. Concrete "U" headwalls located on the waterside (WS) and landside (LS) ends. Flap gate on the WS end. Slide gate on the LS end. [Additional Reference(s): DWR Levee Log, 1993. USACE Sacramento O&M Manual 519, June 1962 (HLM 2.54)] FS Date: 5/3/2016 12:54:00 PM

Overview of levee crown looking south

View of WS slope.

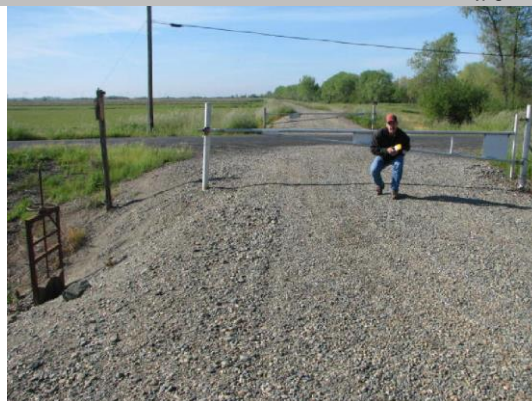
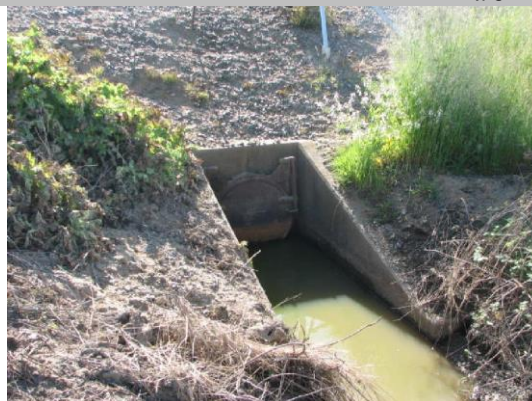
FS\_ID:48042  
DS\_ID:16402  
EP\_NO: N/A  
Repair Type: Non-Urgent  
Crossing Status: Found  
UCIP Comments: 4/27/2016 LS slide gate is full of sediment and needs to be dug out so gate can close fully.7/01/2015 LS screwgate is still silted in and unable to be screwed down all the way. Needs to be cleaned out.5/29/2014 Same as last inspection.12/9/2013 WS flapgate was closed but LS slidegate is heavily vegetated and blocked from closing by sediment.7/10/2013 Same as last inspection.4/19/2012 Minor sediment built up on LS, remove sediment. Need photo of LS slide gate without sediment build up. This crossing was listed in the USACE Periodic Inspection report as Corp's inspect ID# USACE\_CESPK\_M13G\_2011\_p\_0148 for LS gate obstructed by vegetation and WS flap gate is not functioning (propped open).  
FIELD\_STRUCT\_DESC: 36-inch corrugated metal drainage pipe through the levee, 8.8 feet below the crown. Concrete "U" headwalls located on both the waterside (WS) and landside (LS) ends. Flap gate on the WS end. Slide gate on the LS end. Structure used to drain water from Nelson Shippe Road. [Additional Reference(s): DWR Levee Log, 1993. USACE Sacramento O&M Manual 519, June 1962 (HLM 2.63)]

Overview looking south from left levee

Headwall and flap gate located on WS.

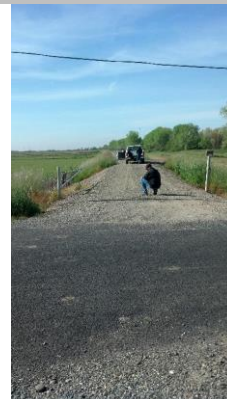
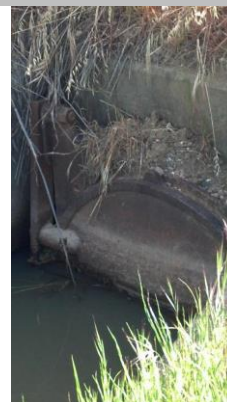
Comment Code					
Inspector Comment					
FS_ID:48043 DS_ID:16403 EP_NO: N/A Repair Type: Non-Urgent Crossing Status: Found UCIP Comments: 4/27/2016 Crossing appears to be in good condition.7/01/2015 WS flap gate is partially blocked by sediment and needs to be cleaned.5/29/2014 Same as last inspection.12/9/2013 Same as last inspection.7/10/2013 LS and WS slopes have been cleared of vegetation and are in good condition.4/19/2012 Burrowing holes located above WS headwall. Limited inspection on WS and LS slopes due to dense vegetation. Need photos of cleared WS & LS slopes. FIELD_STRUCT_DESC: 36-inch corrugated metal drainage pipe through the levee, 8.7 feet below the crown. Concrete "U" headwalls located on the waterside (WS) and landside (LS) ends. Flap gate on the WS end. Slide gate on the LS end. [Additional Reference(s): DWR Levee Log, 1993. USACE Sacramento O&M Manual 519, June 1962 (HLM 2.65)] FS Date: 5/3/2016 1:01:00 PM

Overview at levee crown looking south

Headwall and flap gate located on WS

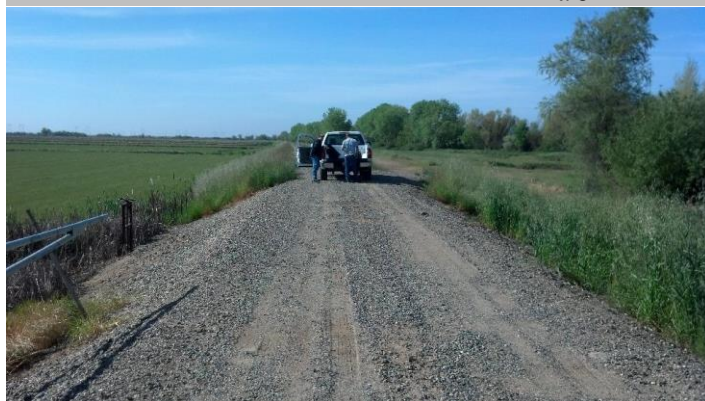
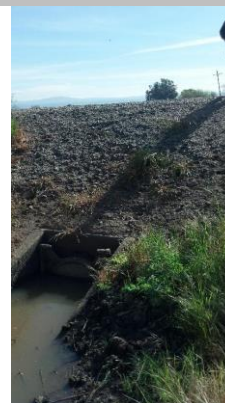
FS\_ID:48048  
DS\_ID:16415  
EP\_NO: N/A  
Repair Type: Non-Urgent  
Crossing Status: Found  
UCIP Comments: 4/27/2016 Both gates were underwater for inspection.7/01/2015 WS flap gate is partially held open by sediment and needs to be dug out to allow it to fully close.5/29/2014 Same as last inspection.12/9/2013 Both gates were out of water and in good condition.7/10/2013 LS and WS slopes are in good condition. Both LS and WS gates were fully submerged in water and unable to be inspected.  
FIELD\_STRUCT\_DESC: 36-inch corrugated metal drainage pipe through the levee, 9 feet below the crown. Concrete "U" headwall on both waterside (WS) and landside (LS) ends. Flap gate on the WS end. Slide gate on the LS. [Additional Reference(s): DWR Levee Log, 1993. USACE Sacramento O&M Manual 519, June 1962 (HLM 2.66)]  
FS Date: 5/3/2016 1:02:00 PM

Overview looking south from left levee

Headwall and flap gate located on WS.

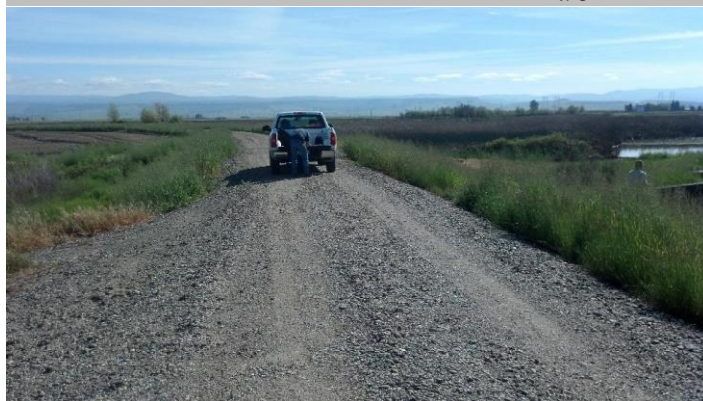
Photo 1 of 2 : UCIP\_FA\_2016\_48046\_67107.jpg

FS\_ID:48046  
DS\_ID:16847  
EP\_NO: N/A  
Repair Type: Non-Urgent  
Crossing Status: Found  
UCIP Comments: 4/27/2016 LS slide gate was still missing. Rest of crossing appears to be in good condition.7/01/2015 There appears to be a LS gate now but both pipe ends were submerged so it was hard to tell for certain.5/29/2014 Same as last inspection.12/9/2013 Pulled sticks from WS flap gate to allow it to close. Ls gate is still missing.7/10/2013 WS and LS slopes have been cleared of vegetation and are in good condition. LS gate is still missing and WS flap gate is still wedged open with sticks.4/19/2012 LS gate missing & limited inspection. Need photos of WS & LS cleared slopes. Description calls for slide gate on LS-slide gate missing. Debris scattered near LS headwall. This crossing was listed in the USACE Periodic Inspection report as Corp's Inspect ID# USACE\_CESPK\_M13J\_2011\_p\_0010 for WS gate wedged open & missing LS slide gate.

Overview looking south on left levee

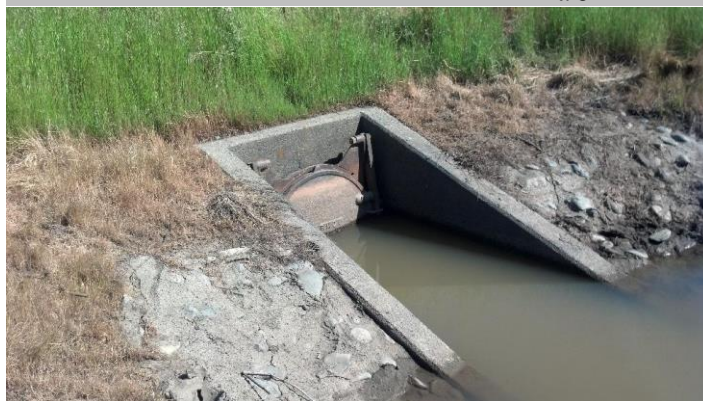
Photo 2 of 2 : UCIP\_FA\_2016\_48046\_67108.jpg

Headwall and flap gate located on WS toe.

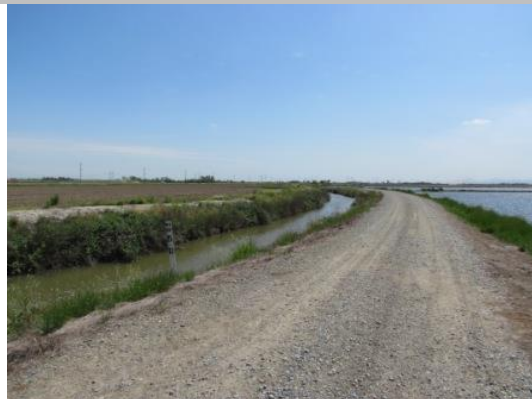
Photo 1 of 1 : FA\_2016\_MA0013\_301\_911\_20160823\_00017.jpg

LM Start	4.04	Rating **	M	Issue No.	911
LM End	4.78	Issue Type +	En	Location *	WS
Category	Earthen Levee			GPS Latitude/Longitude	
				Start	End
Item	Encroachments			39.526653 °	39.534091 °
				-121.699675 °	-121.690404 °
DWR ID	DWR_MA0013_02_s_2012_911				
Comment Code					
DT : Ditch					
Inspector Comment

View of agricultural ditch along the toe.

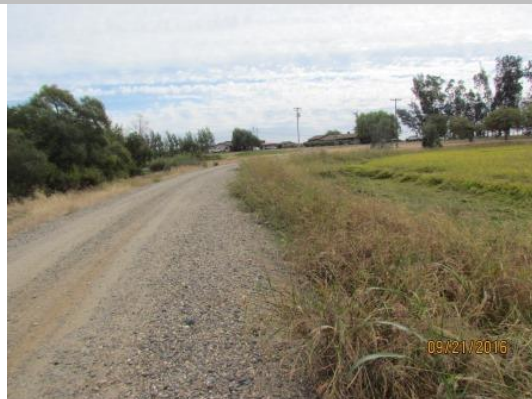
Photo 1 of 1 : FA\_2016\_MA0013\_301\_47\_20161014\_00103.jpg

LM Start	4.80	Rating **	M	Issue No.	47
LM End	5.01	Issue Type +	Ma	Location *	LS
Category	Earthen Levee			GPS Latitude/Longitude	
				Start	End
Item	Vegetation			39.526924 °	39.526272 °
				-121.684802 °	-121.688169 °
DWR ID	DWR_MA0013_02_f_2016_47				
Comment Code					
V1 : Control annual grass and weeds on the levee slopes and easements.					
Inspector Comment

View of dense vegetation at the landside levee toe.

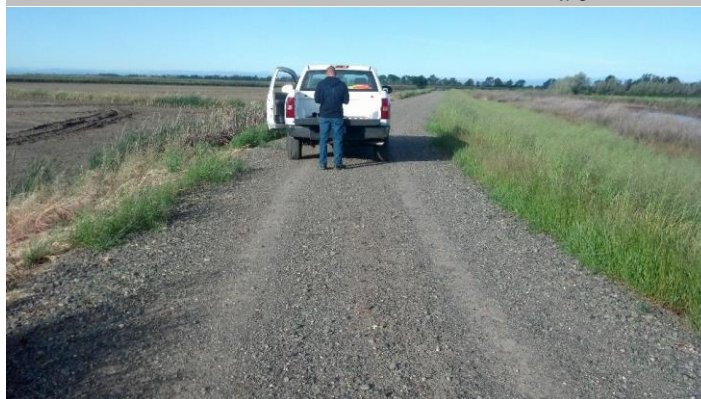
Photo 1 of 2 : UCIP\_FA\_2016\_47724\_67152.jpg

FS\_ID:47724  
DS\_ID:16410  
EP\_NO: N/A  
Repair Type: Non-Urgent  
Crossing Status: Found  
UCIP Comments: 4/27/2016 Pipe appears abandoned. Should be removed.6/30/2015 Pipe still present with the cap on the waterside.5/29/2014 Same as last inspection.12/9/2013 Same as last inspection.7/09/2013 Same as last inspection.4/24/2012 Limited inspection on WS and LS slope due to dense vegetation. Need photos of clear slopes during next inspection. Metal plate bolted on pipe for closure on WS, open on LS.  
FIELD\_STRUCT\_DESC: \*ABANDONED\* 6-inch steel pipe through the levee, 1.6 feet below the crown. Plate bolted on the waterside (WS) end. Open on the landside (LS) end. [Additional Reference(s): DWR Levee Log, 1993. USACE Sacramento O&M Manual 519, June 1962 (HLM 5.41)]  
FS Date: 5/3/2016 1:50:00 PM

Overview of site

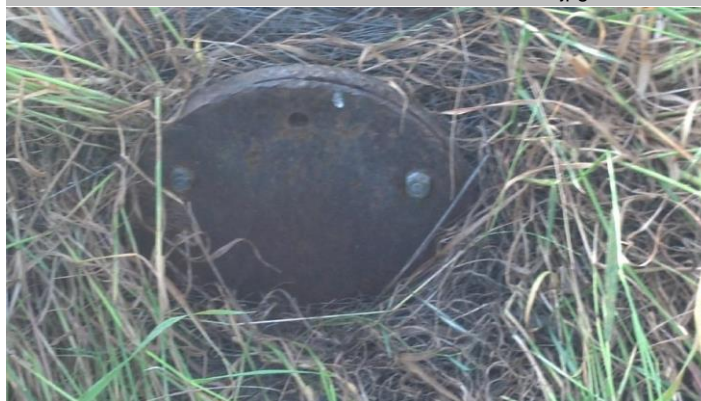
Photo 2 of 2 : UCIP\_FA\_2016\_47724\_67150.jpg

Capped irrigation pipe located on water side of levee

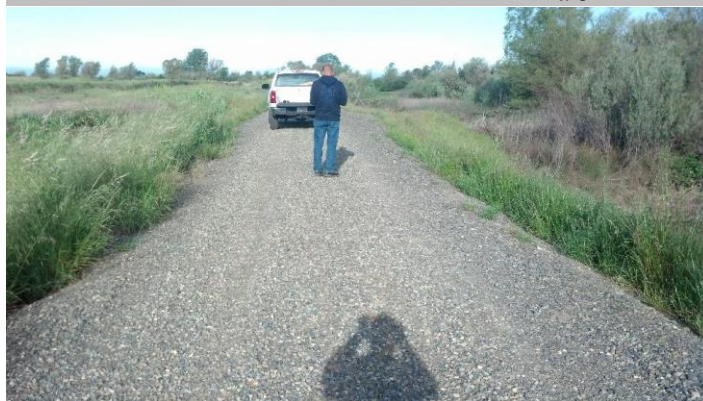
Photo 1 of 2 : UCIP\_FA\_2016\_50046\_67155.jpg

Comment Code					
Inspector Comment					
FS_ID:50046 DS_ID:16411 EP_NO: N/A Repair Type: Non-Urgent Crossing Status: Found UCIP Comments: 9/27/2016 Crossing has been downgraded from Urgent to Non-Urgent--flap gate on WS is present only LS gate missing. (DWR UCIP - omagana)4/27/2016 Both sides of pipe were underwater. Appears that LS gate is still missing. (DWR Sutter Yard - afreitag)6/30/2015 Slide gate still missing on the LS. WS appears to be in good condition. (DWR Sutter Yard - afreitag)5/29/2014 Same as last inspection. (DWR Sutter Yard - afreitag)12/9/2013 Same as last inspection. (DWR Sutter Yard - afreitag)7/09/2013 Same as last inspection. (DWR Sutter Yard - afreitag)4/24/2012 Slide gate missing on LS. Limited inspection on WS and LS slopes due to dense vegetation. Need photos of cleared WS & LS slopes. This crossing was listed in the USACE Periodic Inspection report as Corp's inspect ID# USACE_CESPK_M13H_2011_p_0017 for missing slide gate. (DWR Sutter Yard - omagana) FIELD_STRUCT_DESC: 36-inch corrugated metal drainage pipe through the levee, 9.2 feet below the crown. Flap gate on the waterside (WS) end. Slide gate on the landside (LS) end. Concrete "U" headwalls located on both WS and LS toes. [Additional Reference(s): DWR Levee Log, 1993. USACE Sacramento O&M Manual 519, June 1962 (HLM 5.85)] FS Date: 5/3/2016 1:57:00 PM

Overview looking south

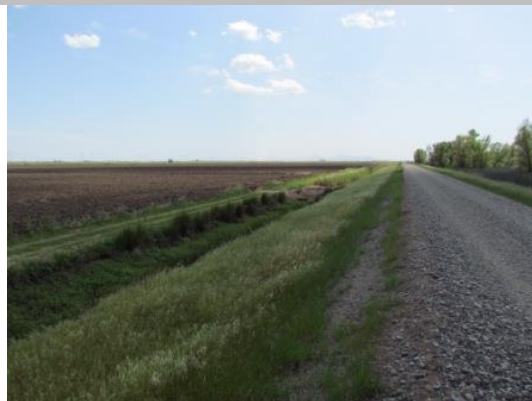
Photo 1 of 1 : FA\_2016\_MA0013\_301\_12\_20160823\_00005.jpg

LM Start	6.18	Rating **	M	Issue No.	12
LM End	7.54	Issue Type +	En	Location *	LS
Category	Earthen Levee			GPS Latitude/Longitude	
				Start	End
Item	Encroachments			39.520843 °	39.502958 °
				-121.706345 °	-121.716953 °
DWR ID	DWR_MA0013_02_s_2012_12				
Comment Code					
DT : Ditch					
Inspector Comment

View of the agricultural ditch along the toe.

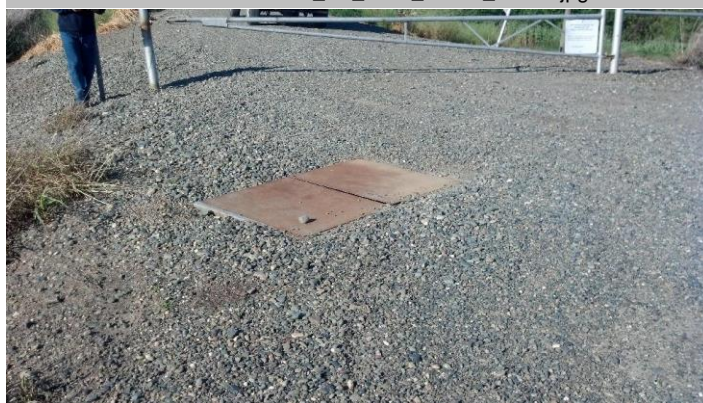
Photo 1 of 2 : UCIP\_FA\_2016\_47733\_67191.jpg

Buried cable box located on the LS edge.

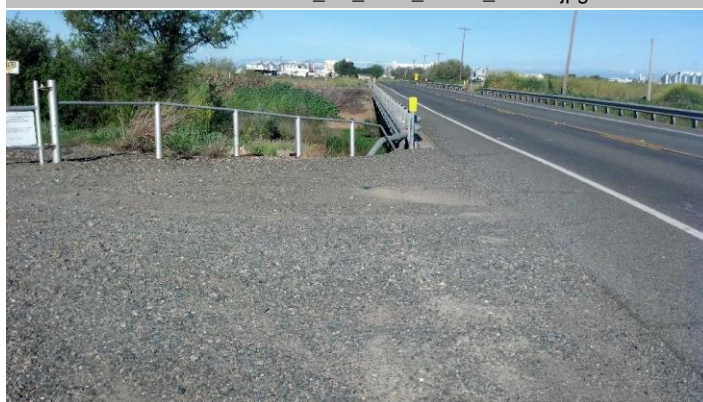
Photo 2 of 2 : UCIP\_FA\_2016\_47733\_67192.jpg

WS view cable line attached to highway bridge.

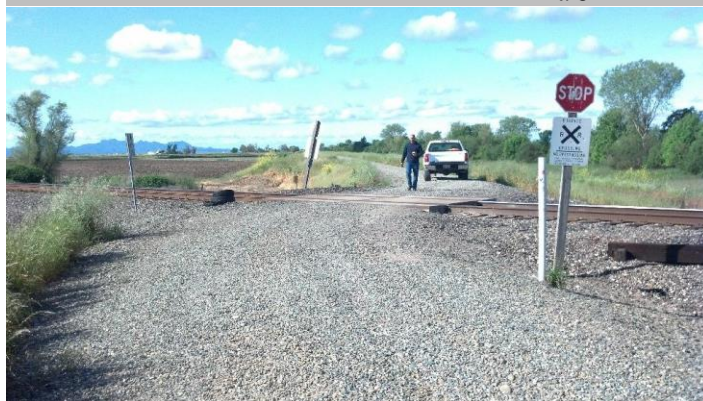
Photo 1 of 2 : UCIP\_FA\_2016\_47742\_67292.jpg

Overview of levee crown at crossing.

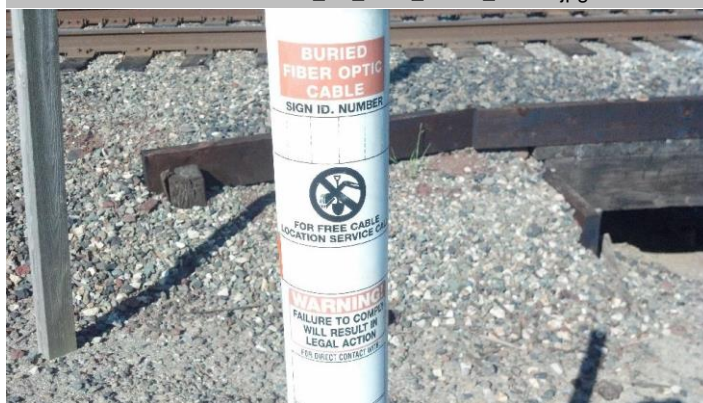
Photo 2 of 2 : UCIP\_FA\_2016\_47742\_67291.jpg

Marker for buried fiber optic cable on WS.

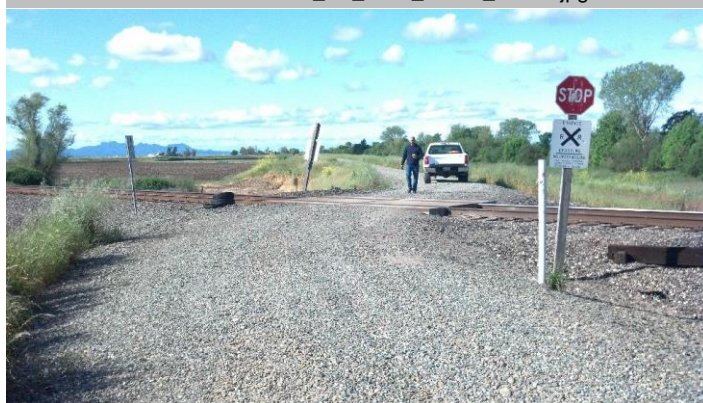
Photo 1 of 2 : UCIP\_FA\_2016\_47743\_67295.jpg

Overview of levee crown at crossing.

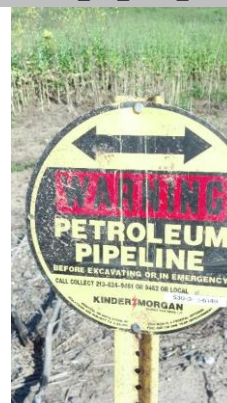
Photo 2 of 2 : UCIP\_FA\_2016\_47743\_67294.jpg

WS marker with utility contact information.

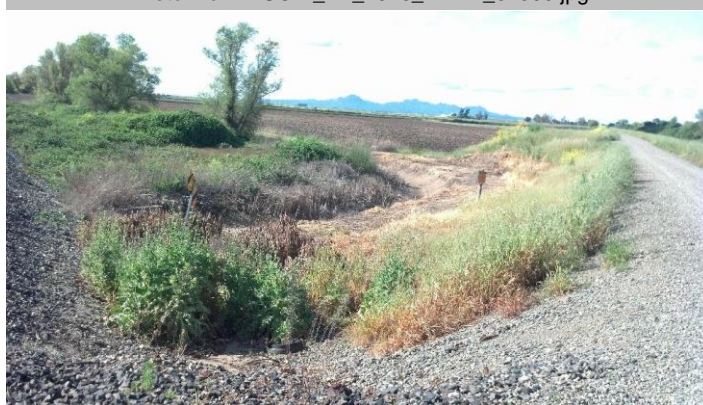
Photo 2 of 2 : UCIP\_FA\_2016\_47744\_67300.jpg

Marker located on LS.

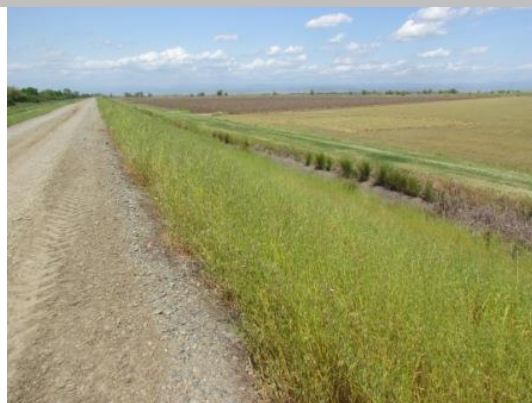
Photo 1 of 1 : FA\_2016\_MA0013\_301\_13\_20160823\_00006.jpg

LM Start	10.03	Rating **	M	Issue No.	13
LM End	10.52	Issue Type +	En	Location *	LS
Category	Earthen Levee			GPS Latitude/Longitude	
				Start	End
Item	Encroachments			39.471517 °	39.465113 °
				-121.739433 °	-121.743592 °
DWR ID	DWR_MA0013_02_s_2012_13				
Comment Code					
DT : Ditch					
Inspector Comment

View of the agricultural ditch along the toe.

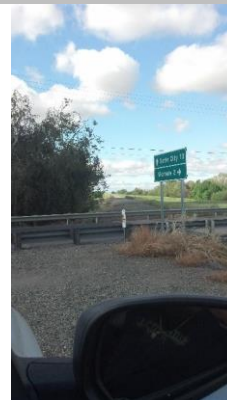
Photo 2 of 2 : UCIP\_FA\_2016\_47746\_67333.jpg

Utility is angled. Alignment crosses highway.

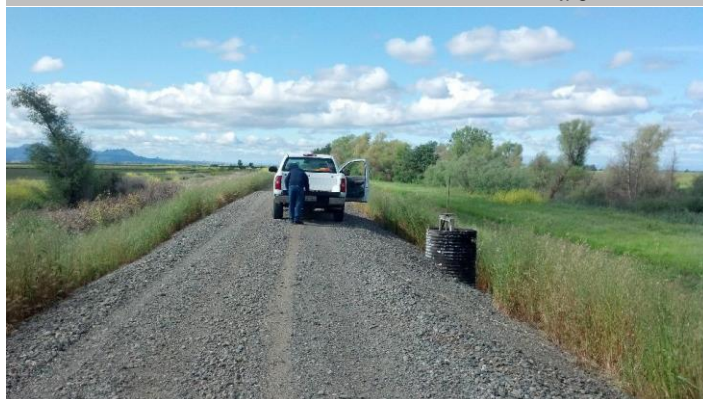
Photo 1 of 2 : UCIP\_FA\_2016\_47748\_67336.jpg

FS\_ID:47748  
DS\_ID:16385  
EP\_NO: N/A  
Repair Type: Non-Urgent  
Crossing Status: Found  
UCIP Comments: 4/26/2016 LS headwall was visible but gate was underwater. WS still heavily vegetated and unable to be inspected. Vegetation needs to be cleared back.6/30/2015 WS heavily vegetated passed the toe-road and could not make it to the WS pipe end for inspection. Vegetation needs to be cleared back. LS pipe end was fully submerged under water.5/28/2014 Same as last inspection.12/4/2013 Same as last inspection.7/08/2013 LS slope has been cleared of vegetation and is in good condition. LS headwall is now visible but mostly underwater so unable to do full inspection. WS is still vegetated.4/24/2012 LS pipe & slide gate sedimented in. Limited inspection WS and LS slopes due to dense vegetation. Need photos of cleared WS and LS slopes during next inspection. This crossing was listed in the USACE Periodic Inspection report as Corp's inspect ID# USACE\_CESPK\_M13F\_2011\_p\_0147 for limited visibility of LS and WS.

Overview of crossing looking downstream at the left bank of Cherokee Canal.

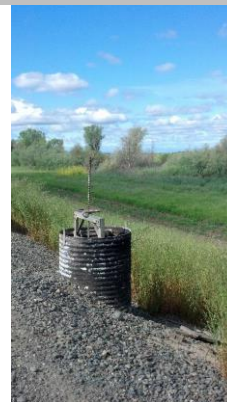
Photo 2 of 2 : UCIP\_FA\_2016\_47748\_67337.jpg

Stand pipe with screw gate WS

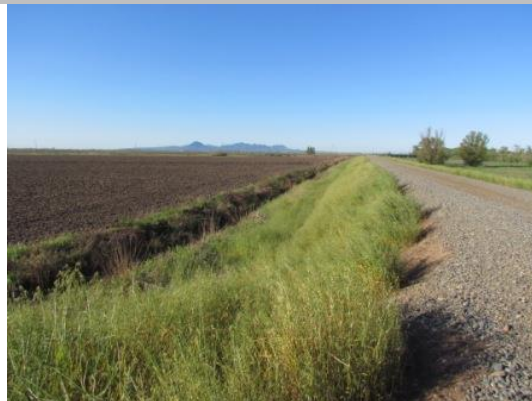
Photo 1 of 1 : FA\_2016\_MA0013\_301\_19\_20160823\_00008.jpg

LM Start	13.40	Rating **	M	Issue No.	19
LM End	16.00	Issue Type +	En	Location *	LS
Category	Earthen Levee			GPS Latitude/Longitude	
				Start	End
Item	Encroachments			39.428192°	39.414202°
				-121.768443°	-121.781863°
DWR ID	DWR_MA0013_02_s_2012_19				
Comment Code					
DT : Ditch					
Inspector Comment

View of the agricultural ditch along the toe.
